# Japan Airlines 706 Accident Investigation Report

Japan Airlines McDonnell Douglas MD-11 JA8580

Over Shima Peninsula, Mie Prefecture, Japan

ALPA Japan Technical Support Team

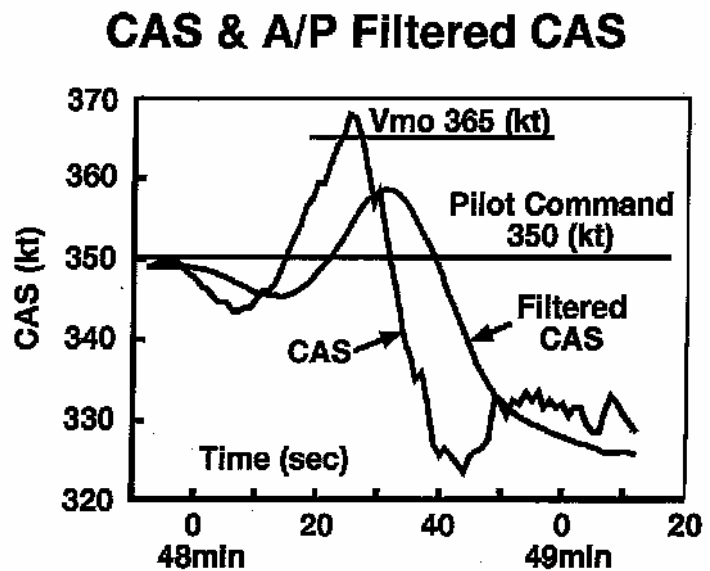
The MD-11 Autopilot System uses a filtered airspeed signal to smooth out the signal and prevent the FCC from responding too sensitively to momentary airspeed changes. This results in a delayed autopilot response to rapid changes in airspeed. According to McDonnell Douglas reference material, shown in the figure on the right, it can be assumed that there was a noticeable difference between the indicated airspeed and the filtered airspeed signal.

The MD-11 flight crew of Japan Airlines were never informed of the fact that the FCC uses a filtered airspeed signal, nor is there any indicator in the cockpit that displays this filtered airspeed or the dissociation of between the two signals.

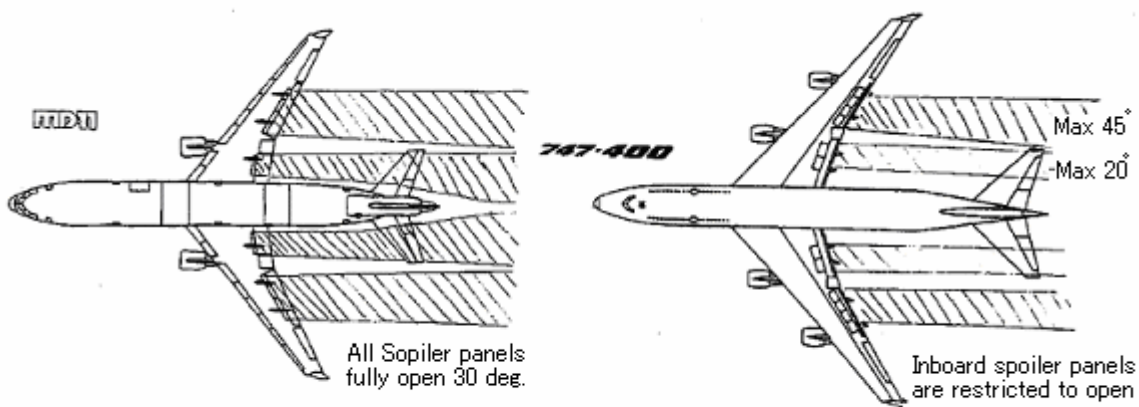
**1.16.7 Spoilers**

The spoiler system on the MD-11, functions as speed brakes during flight, with all the spoiler panels opening to an angle of 30°. In comparison, the spoiler panels close to the fuselage on the B747 are limited in travel, which prevents the wake from these inboard spoilers from adversely affecting the horizontal stabilizer aerodynamically. Spoiler wake is usually not considered a problem and evaluation on the simulator did not reveal anything to the contrary. However, when the angle of attack undergoes large fluctuations during flight in vertical vortices, the downwash from the wing may be in a different position from normal and possibly cause the wake from the spoilers to adversely affect the horizontal stabilizer.
